# ENVIRONMENTAL ASSESSMENT WORKSHEET

**Project:** Nigon Development

**Location:** Rochester, MN

*October 2025*

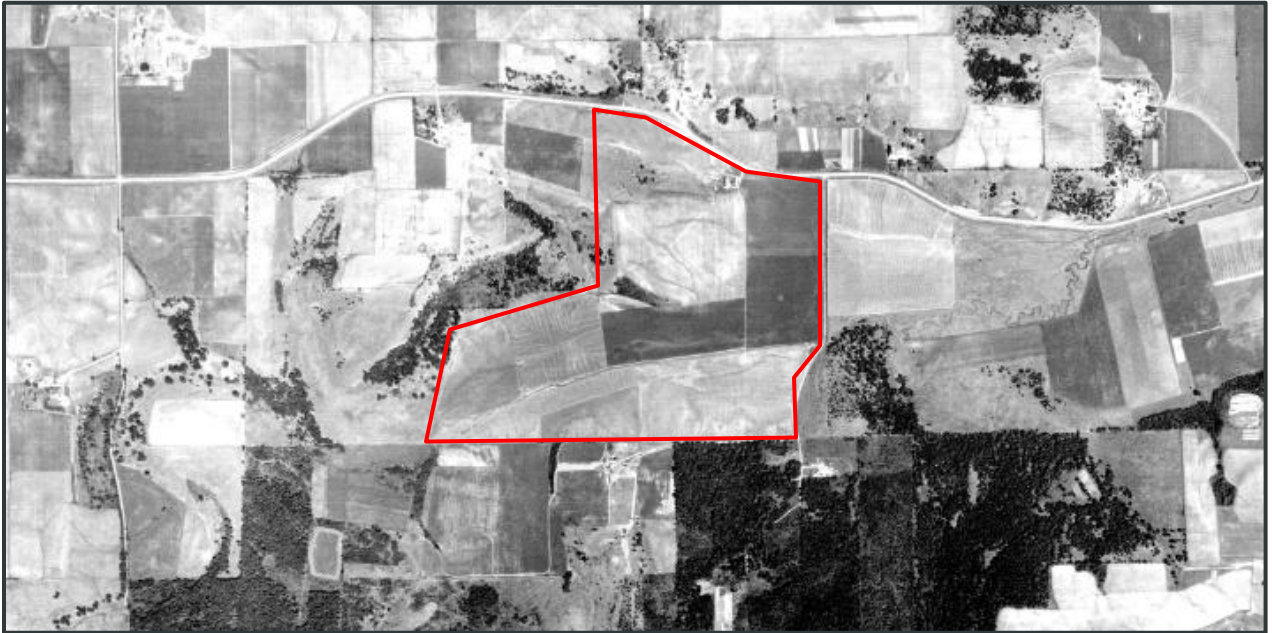
**Photograph 1. Aerial Photograph of the Site in 1940**

Historically, the site has been used for agricultural purposes, with no significant structures except for a few houses/farmstead structures in the northern portion. A review of Google Earth aerial imagery from 1991 to the present and a 1940 historical photograph from the John R. Borchert Map Library indicates that the site has remained largely unchanged during this period. Aerial photographs from 1940 to 2024 (Photographs 1 through 2) illustrate the site's historical conditions, with red lines delineating the approximate project location. Additional Aerial Photographs of the site can be found in the Phase I Environmental Site Assessment (provided under separate cover).

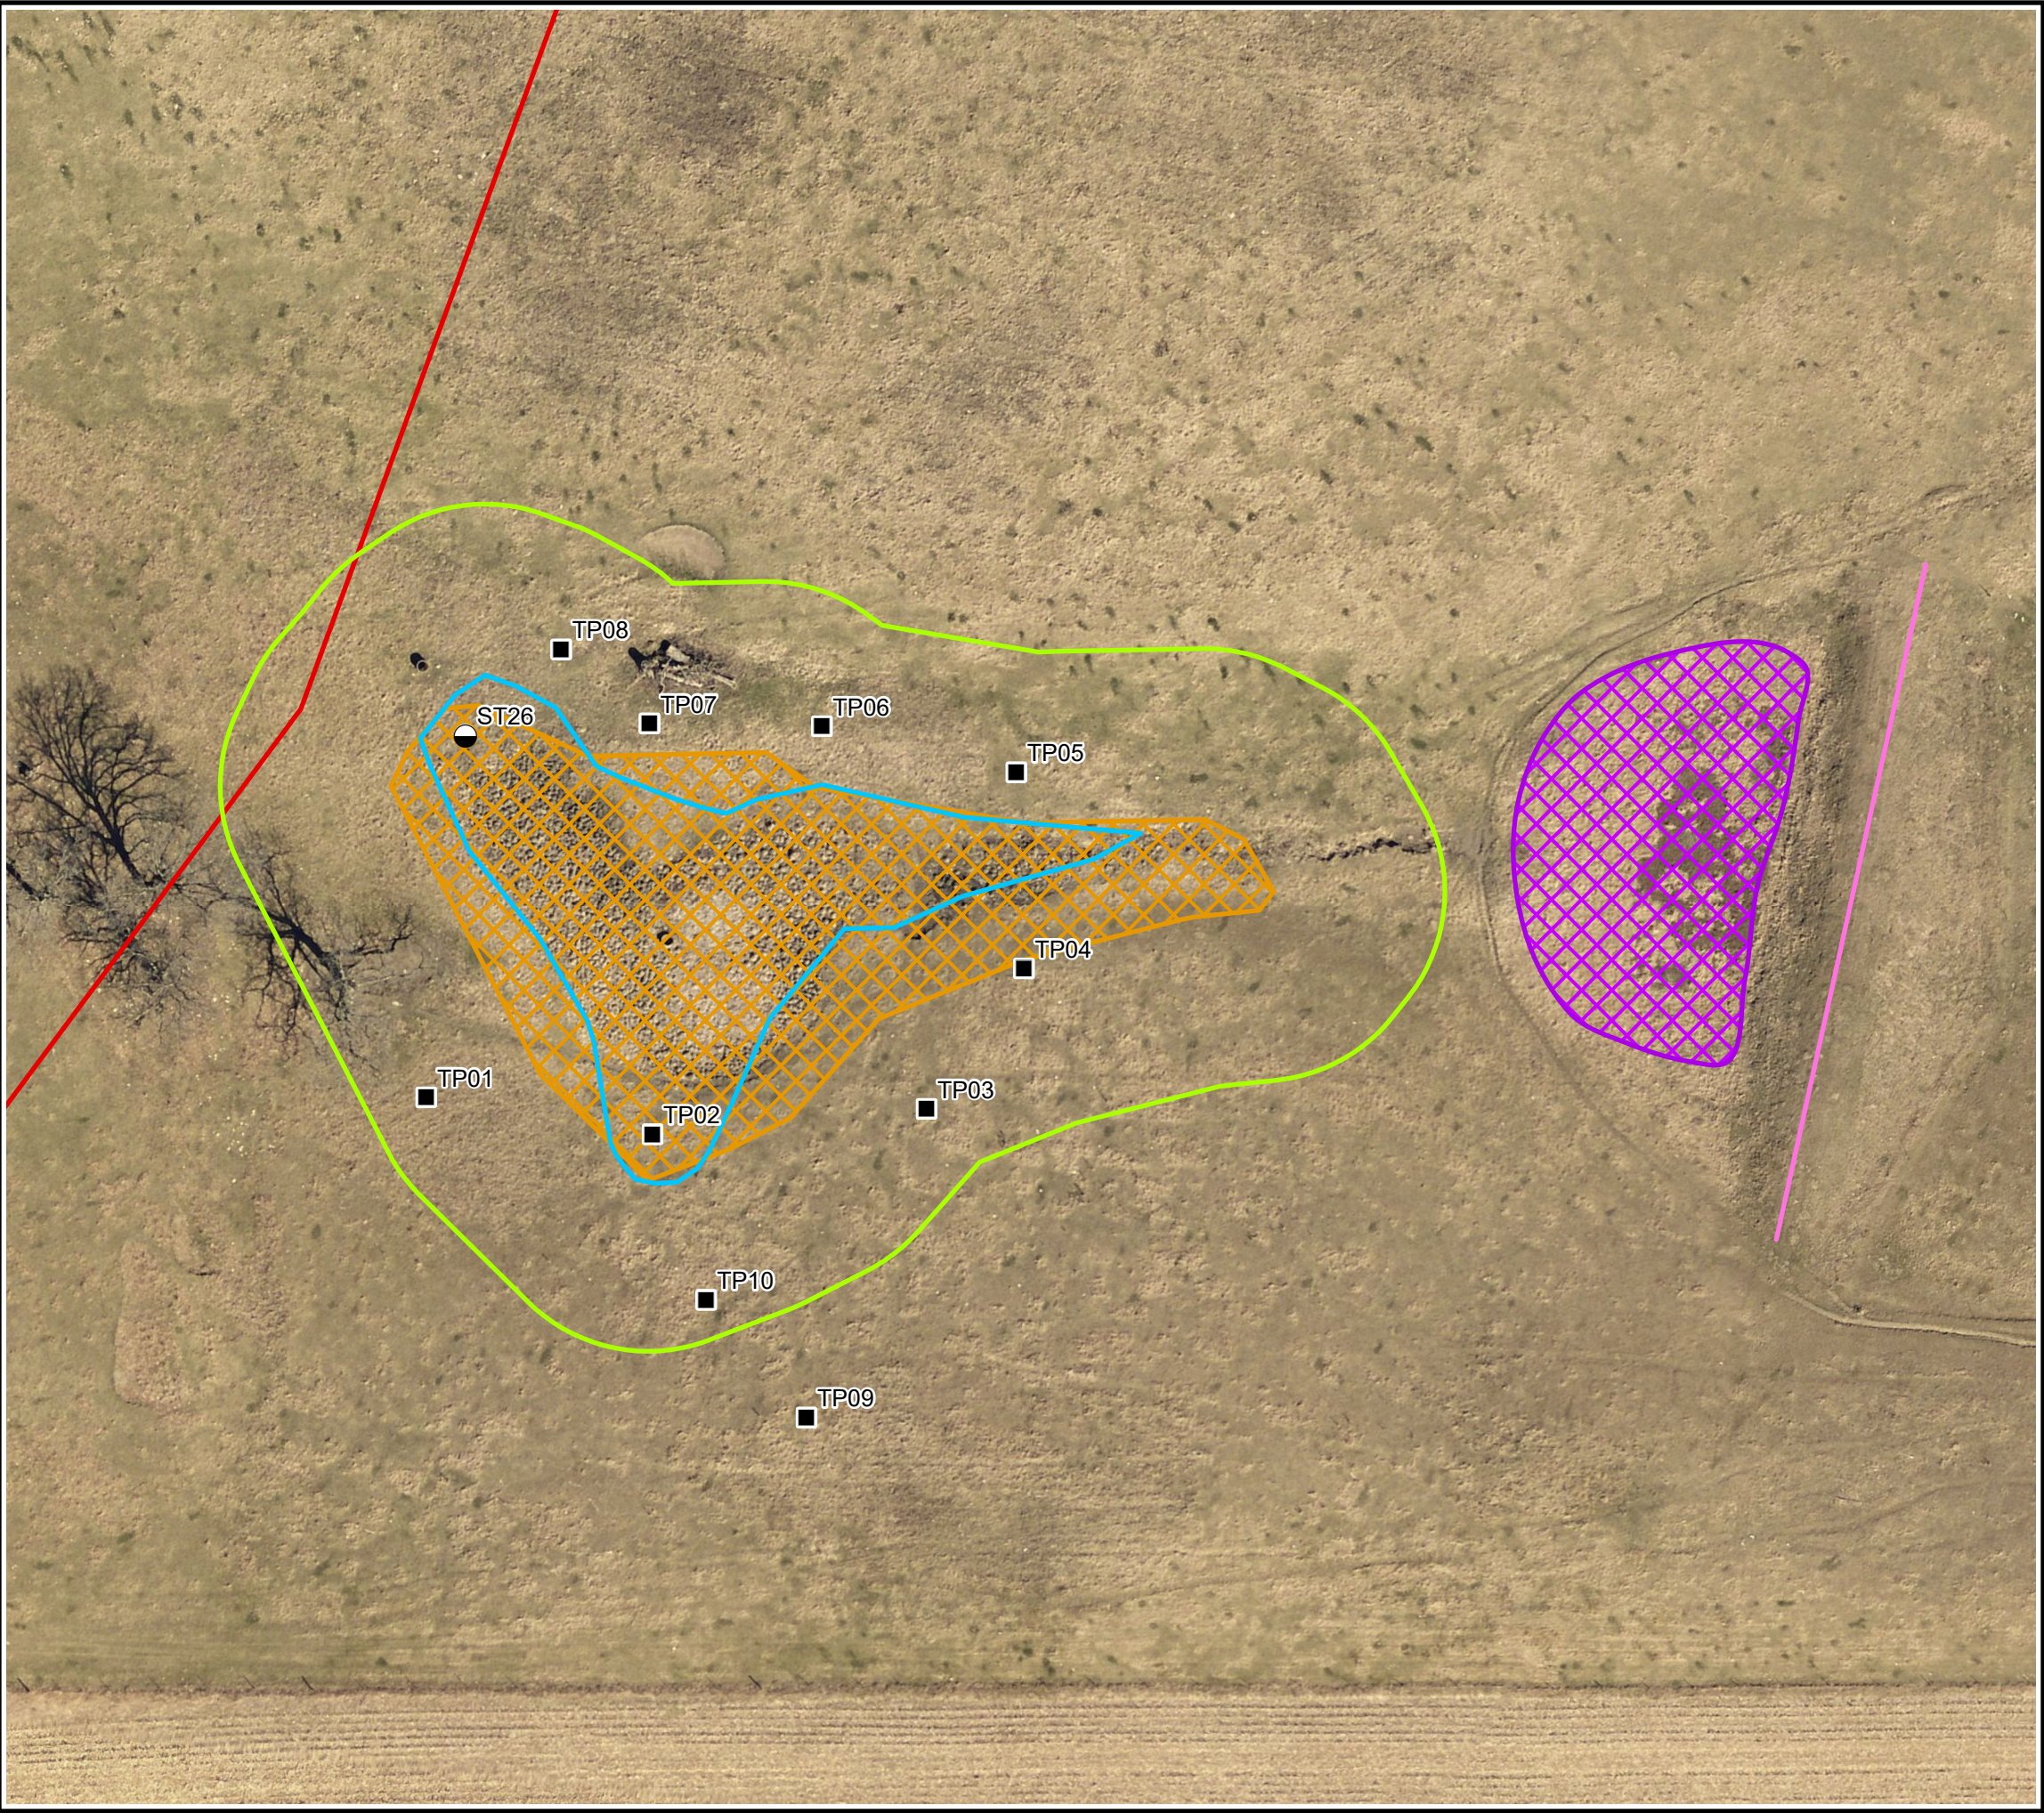
**Figure 6**

***Observed Decorah Shale  
Influence Boundary Map***
